OCCC – Central County Campus

The Central County Campus building is a two story 80,000 sf facility that includes classrooms, science labs, nursing labs, the campus commons, facility staff and administration offices. Roofs are framed with wood trusses. Walls are a mix of wood framing and CMU. The Roof system is asphalt composition shingle, and the siding systems are a mix of brick and cement fiber siding.

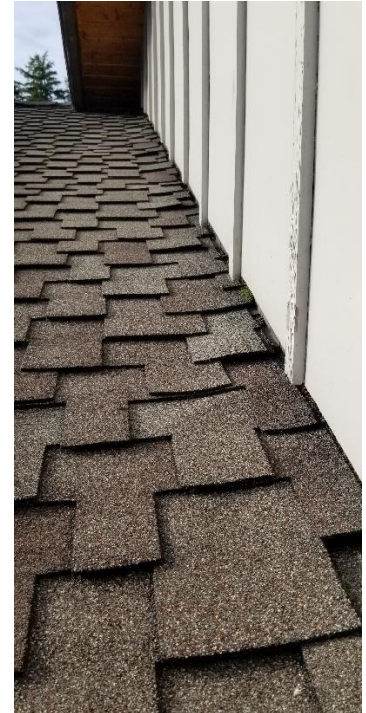
Roof Systems

- Existing roofs are leaking in numerous locations as detailed under a separate attached report

- Remove existing asphalt shingle roof system
- Inspect existing plywood for damage and replace – assume 100 sheets of ½" plywood.
- Install continuous adhered air vapor barrier
- Install new flashing systems
- Install stainless steel saddles at all
- Install new prefinished aluminum standing seam roof

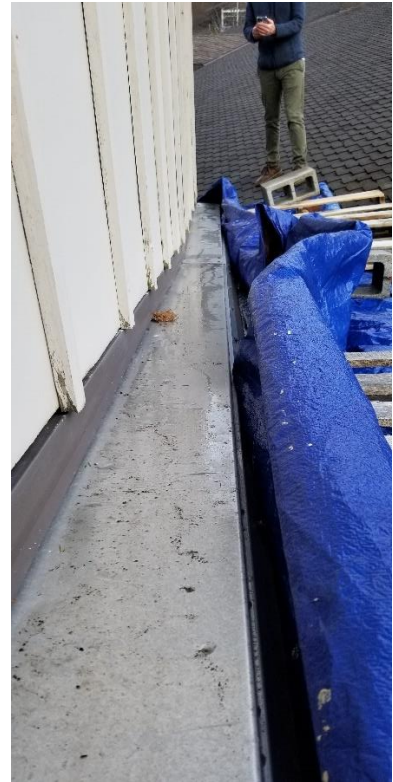
Seismic Joint

- Existing seismic joint is leaking

- Remove seismic joint cover and flashing
- Repair gasket
- Replace cover
- Seal all joints
- Install new pre-finished aluminum flashing cover with standing seam joints over the repaired system.

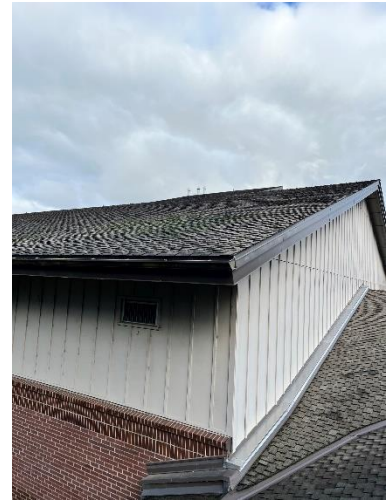
Exterior Cement Fiber / Cedar Siding Systems

- All cement fiber siding and soffits need to be repainted.
- Repainting needs to occur every 8 years going forward.

- Remove all flaking paint
- Remove and reinstall all sealant associated with the siding system
- Prime entire surface with an elastomeric paint system intended for cement fiber siding and cedar trim.

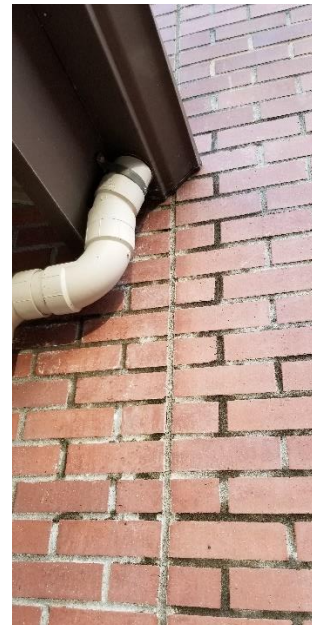
Exterior Brick Systems

- Brick needs to be resealed every 8 years going forward
- Brick control joints need to be replaced every 12 years

- Power wash brick and reseal.
- Remove silicone control joints and replace

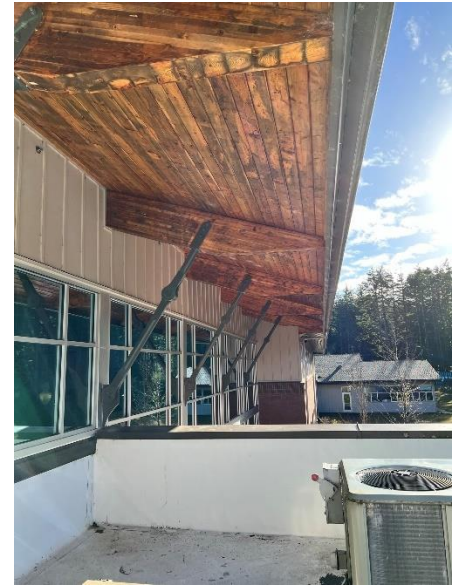
Exterior Wood With Clear Finish

- Finish has aged, cracked and peeled. Wood is stained and has grayed.
- Wood with clear finish should be recoated every three years and sanded and refinished every 12 years as needed

- Sand down wood to remove finish and as much of the staining as possible.
- Apply a wood stain remover product
- Apply three coats of clear spar urethane varnish – satin finish

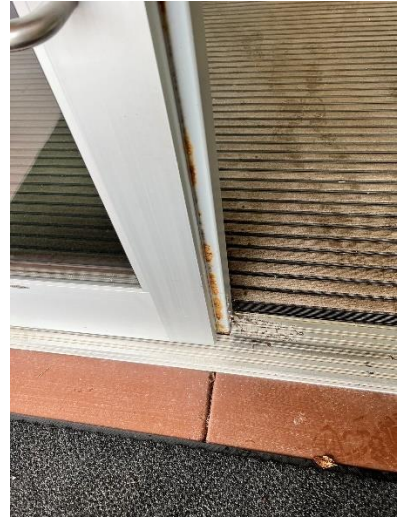
- Prefinished removable mullions are beginning to rust.

- Remove as much rust as possible with wire brush, abrade the rest of the surface
- Repaint with a DTR paint system. Color to match existing.

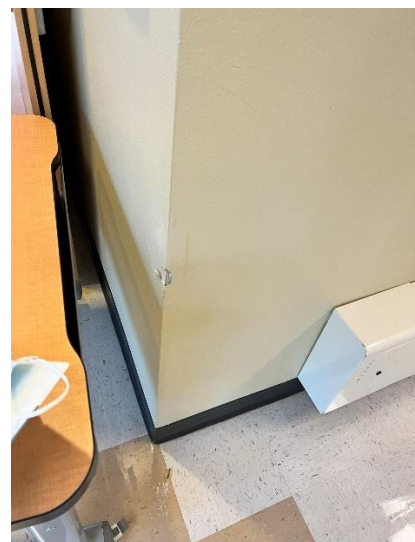
- Interior outside corners at numerous locations are damaged.

- Repair corners and paint if exposed
- Provide 2"x2" x4'-0" Stainless Steel adhered corner guards

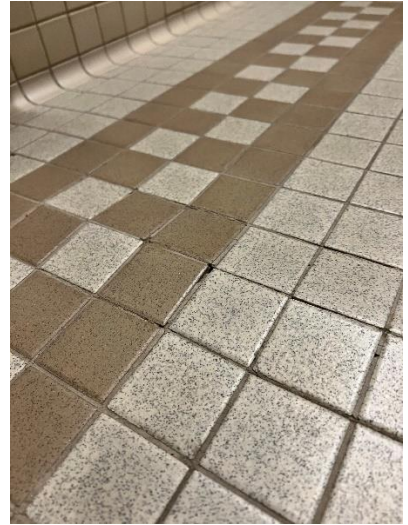
Broken Tile at Shower Rooms

- Substrate has heaved at shower rooms

- Remove loose tile and adjacent adhered tiles
- Grind substrate smooth
- Reinstall tile system to match existing

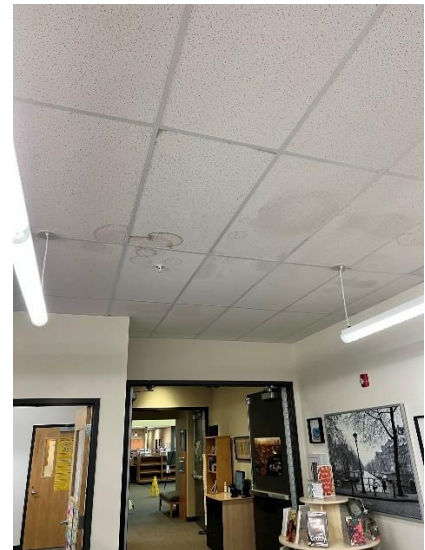
Damaged Ceiling Tile

- Tile has been damaged from roof leaks

- Replace with new after roof has been replaced

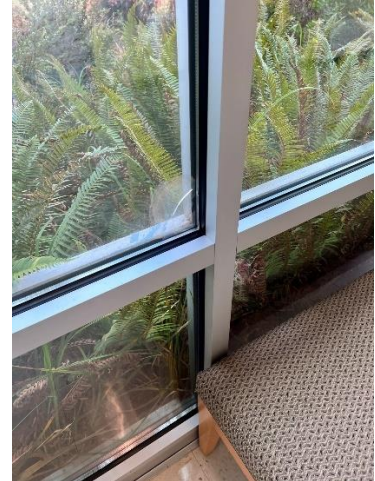
Windows at first floor corridor

- One window is cracked and one window has broken seals in the first floor corridor near the ramp.

- Replace

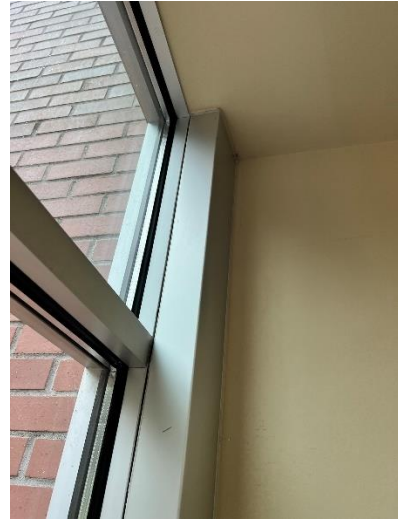
Interior joint sealant at windows

- Sealant joint between window frames and aluminum window trims have failed at the second floor windows at the commons NE side.

- Remove and replace with a color matched STPE sealant system

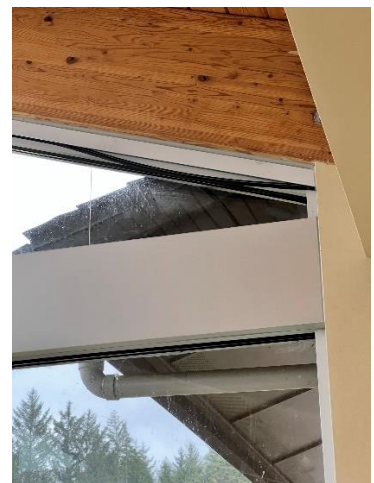
Loose Weatherstripping

- Weather stripping at window heads is loose

- Apply a rubber compatible adhesive and reinsert weatherstripping

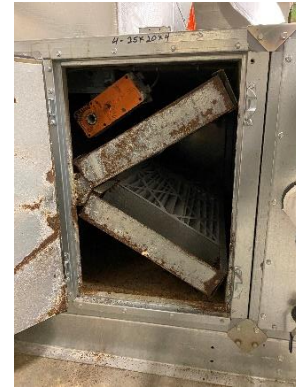
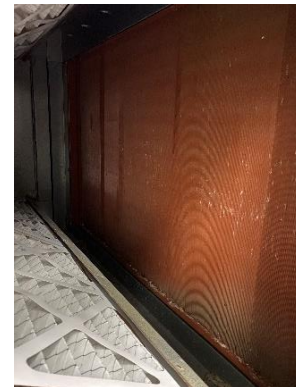
HVAC – Air Handling Unit Component Replacement

- Some existing air handlers have severely rusted sections due to high humidity and coastal conditions.
- Some unit's coil connections show corrosion due to joining of different metals.

- Provide new filter sections and coils for affected units.
- Remove corroded pipe and replace with new pipe of same material, or provide dielectric union.
- Provide new moisture sensor in bottom of intake louver plenums to detect standing water pooling in plenum/clogged drain.
- Provide new mist elimination filter at outside air intake louver.

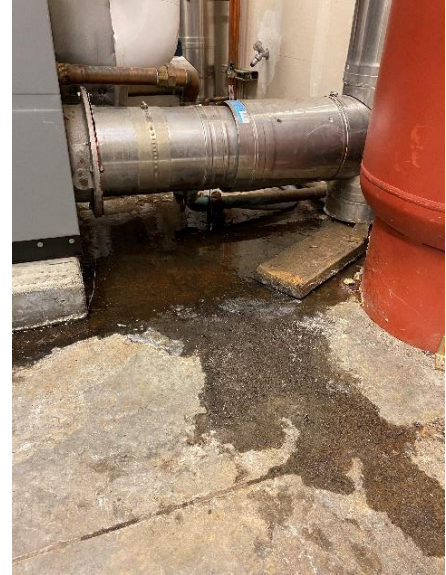
HVAC – Boilers condensation issue

- During some operating conditions, Boiler #1 has severe condensation in the exhaust flu which has caused flooding in the mechanical room.

Condensation problem is currently limited to Boiler #1, but campus facilities has noted the boilers do not operate in a lead/lag configuration as intended. It is possible the issues may affect Boiler #2 if lead/lag operation is corrected. Recommend issue resolutions are provided for both boilers.

- Revise control sequences based on operation manual to ensure boiler operates within manufacturer's recommended setpoints.
- Provide floor-mounted water dam or re-slope floor of mechanical room to direct condensation to floor sink.

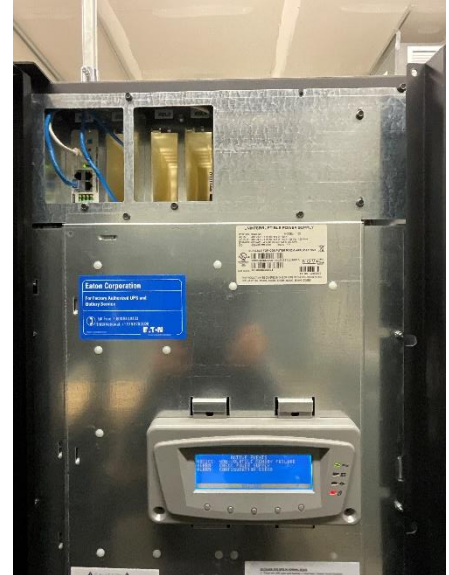
- Existing 120kVA UPS has been reported to have a failure of its non-volatile memory storage, making the system vulnerable during extended power outages.
- Getting onsite service from the manufacturer has been challenging.
- UPS batteries are nearing end of life and are due for replacement.

- Repair or replace existing UPS system.

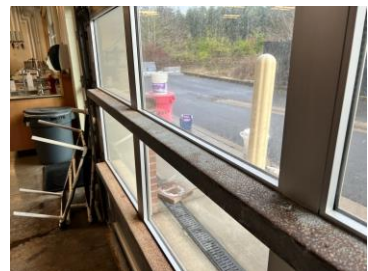
Rust at Overhead Door Stiffeners

- Horizontal stiffeners and track at overhead door are corroding.

- Contract with Overhead Door Co or approved to remove stiffeners and replace with aluminum if possible and remove track and replace. If steel is required, all steel should be hot dip galvanized after fabrication.

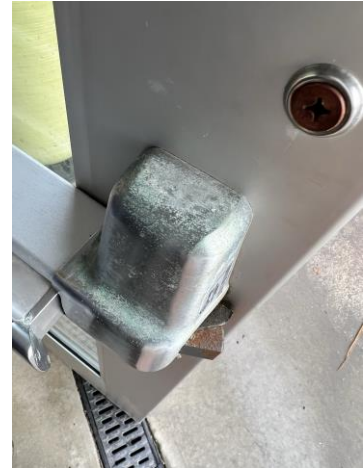
Door Hardware is Corroding

- Steel parts on panic devices are corroding

- Clean corrosion off of aluminum and stainless portions and replace steel components.

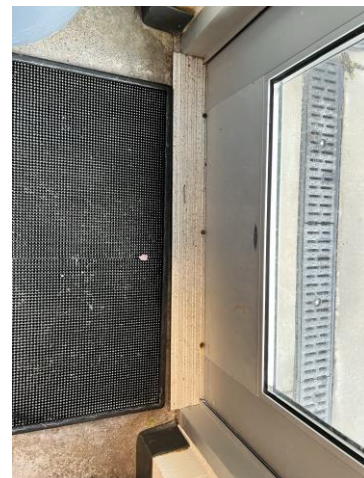
Fasteners at door hardware corroding

- Fasteners at door hardware at numerous locations have corroded.

- Remove and replace with matching size, but in stainless steel.

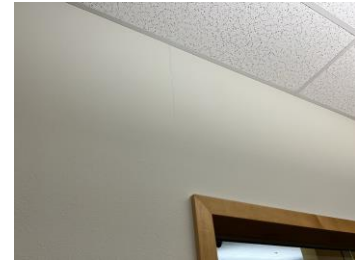
- Cracks have appeared in the gypsum board at the foyer in numerous locations, primarily at the interior relite to room 110, at the openings into Reception 103 and at the beam saddle in the north wall of Upper Lobby 201 near gridline 6. Recurring cracks in these types of locations are typically caused by differential settlement.
- Cracks have also occurred in the hallway at both floors. Control joints should have been installed in continuous gypsum board runs that exceed 30'. Joints should be added in the hallways where the cracks have occurred.
- Recurring cracks in these types of locations are typically caused by differential settlement. But can also be caused by shrinkage due to drying wood framing.
- Differential settlement of up to ½" is indicated in the Geotechnical Report from URS dated January 16, 2006 which is enough to cause cracking.

- Add vertical "V" shaped control joints in the gypsum board that extend down to the substrate at all locations where cracking has occurred. Joint should be USG Control Joint 093 or similar.
- Gypsum board will need to be refinished and repainted.
- In some cases, an additional stud may need to be installed to support the joint.
