OCCC – Central County Campus

The Central County Campus building is a two story 80,000 sf facility that includes classrooms, science labs, nursing labs, the campus commons, facility staff and administration offices. Roofs are framed with wood trusses. Walls are a mix of wood framing and CMU. The Roof system is asphalt composition shingle, and the siding systems are a mix of brick and cement fiber siding.

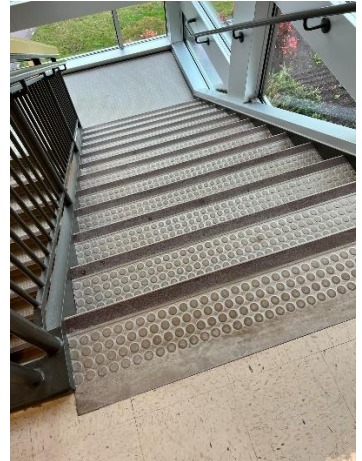
- This is an aesthetic issue. A conditioner can be used to rejuvenate the appearance.

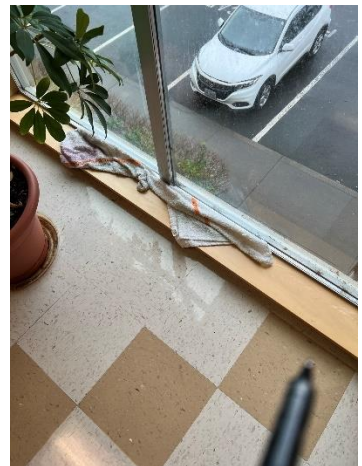
Leak at North Second Floor Corridor Window

- Window is leaking and sill is receiving water

- Exterior window sealants should be removed and replaced.
- Water is likely coming from roof leaks and should be resolved once roof is replaced.

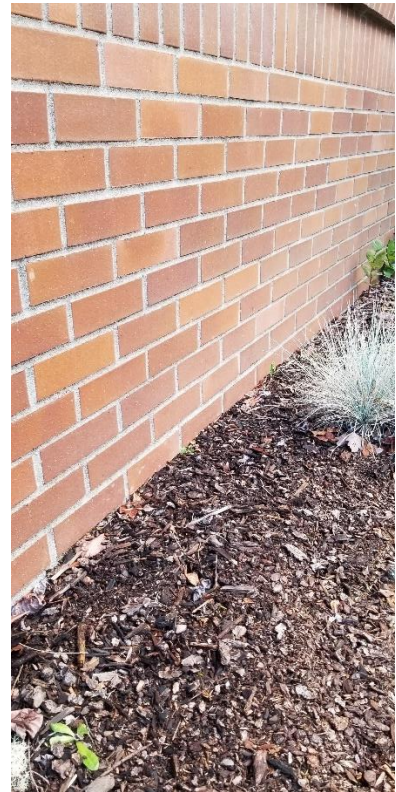
Perimeter Soil Buildup

- Soil has built up over time at the perimeter of the building, blocking brick weeps and causing potential rot / decay at siding systems.

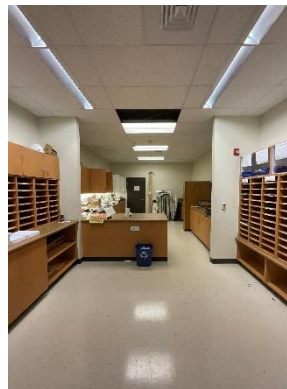
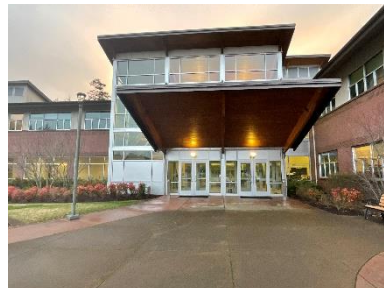
- Interior lighting is fluorescent.
- Building mounted exterior lighting is Metal Halide
- Pole lights are High Pressure Sodium
- These older technologies are costly to maintain, requiring regular lamp and/or ballast replacement.
- Controllability for these fixtures is also limited, minimizing energy savings potential through lighting controls.

- Replace and/or retrofit interior lighting with dimmable LED fixtures/lamps.
- Replace and/or retrofit exterior lighting with LED fixtures/lamps.
- Consider luminaires with Luminaire Level Lighting Controls (LLLC). See Lighting Controls section for more information.

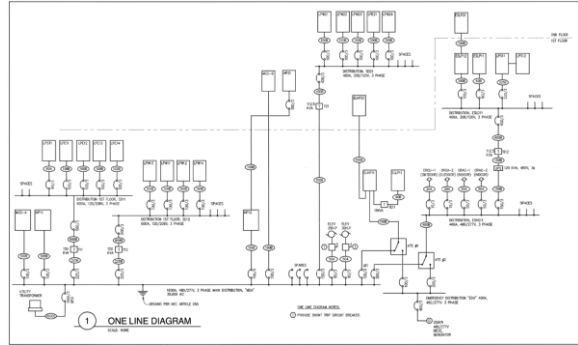
- Periodic testing of electrical system components is recommended to monitor regular deterioration of equipment, devices, connections, and conductors over the system's useful life. Monitoring the electrical system helps to predict and determine scheduled

replacements of system components, minimizing operational downtime and improving worker safety.

- Develop preventative maintenance schedule per ANSI/NETA recommendations.
- Visually inspect equipment condition, connections, anchorage, and alignment.
- Perform electrical and mechanical test and inspect operation, connections, conductor insulation, and tap settings.
- Clean and lubricate equipment.

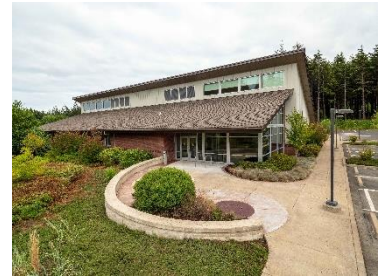
- All cement fiber siding and soffits need to be repainted.
- Repainting needs to occur every 8 years going forward.

- Remove all flaking paint
- Remove and reinstall all sealant associated with the siding system
- Prime entire surface with an elastomeric paint system intended for cement fiber siding and cedar trim.

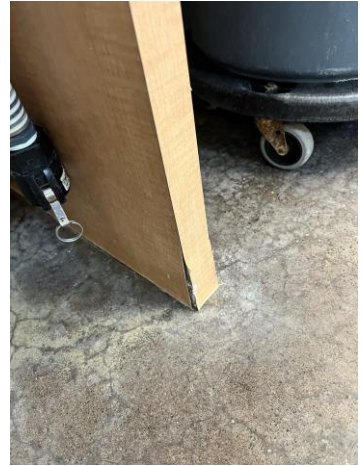
Water Damage at Cabnetry

- Cabinetry with plywood legs has swelled due to water infiltration in two areas.

Issue Cut cabinetry leg off 6" above floor and install stainless steel fabricated legs.

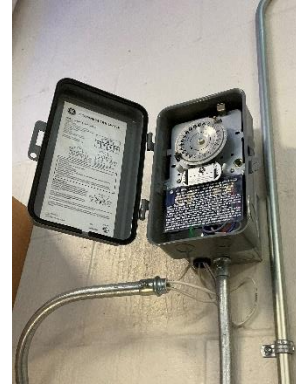
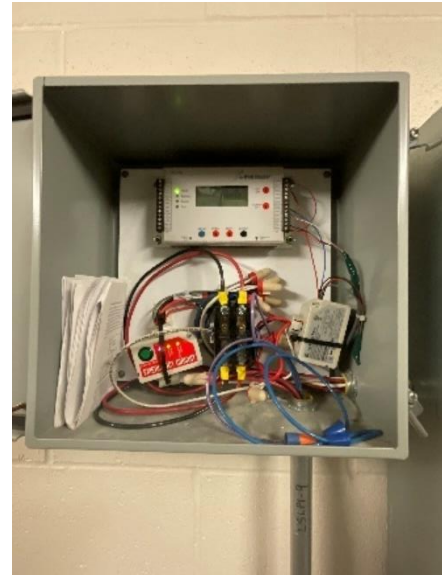
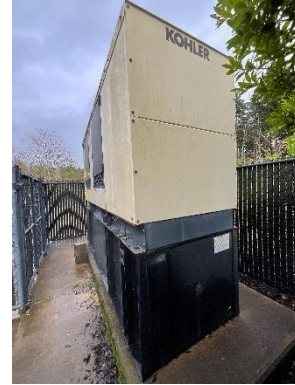
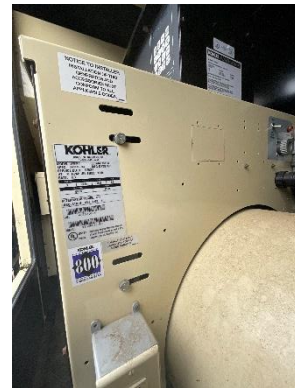
Emergency Power Systems – Generator Reliability

- The facility is currently backed up via a 150kW diesel generator. There have been several instances in which the equipment has not successfully started. When the generator does fire, it is often after a failed startup cycle.
- The generator servicer has reviewed the equipment and the resolution has been unclear.
- It is possible that the generator is mis-firing due to equipment inrush currents. A study should be performed to analyze the startup characteristics of connected equipment.
- If the startup characteristics of connected equipment are within the equipment ratings, the equipment may require replacement.

- Provide an additional backup power source to serve critical loads – refer to the following section on Standby Power and Central Battery UPS.
- Conduct a study of connected loads to confirm compatible equipment ratings. Provide motor soft starters for connected equipment to limit inrush current upon equipment startup. Account for planned future loads.
- If equipment persists to misfire after studying and adjusting motor startup currents, replace the generator with new.

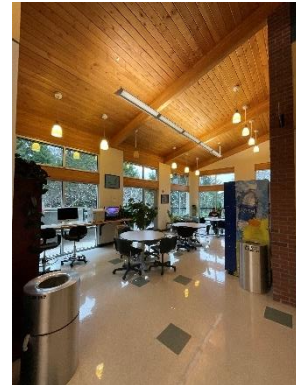
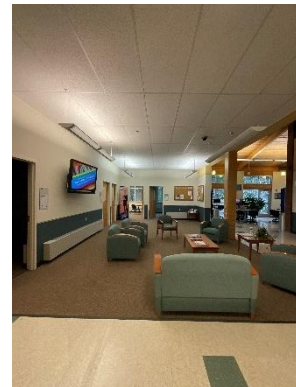
Lighting Systems – Luminaire Upgrade

- Interior lighting is fluorescent.
- Building mounted exterior lighting is Metal Halide
- Exterior signage lighting is fluorescent.
- Pole lights have been converted to LED.
- Older lighting technologies are costly to maintain, requiring regular lamp and/or ballast replacement.
- Controllability for these fixtures is also limited, minimizing energy savings potential through lighting controls.

- Replace and/or retrofit interior lighting with dimmable LED fixtures/lamps.
- Replace and/or retrofit exterior lighting with LED fixtures/lamps.
- Consider luminaires with Luminaire Level Lighting Controls (LLLC). See Lighting Controls section for more information.

Quantification: Full interior and exterior replacement. Include exterior pole lights to align with replacements at the other campuses and simplify maintenance.

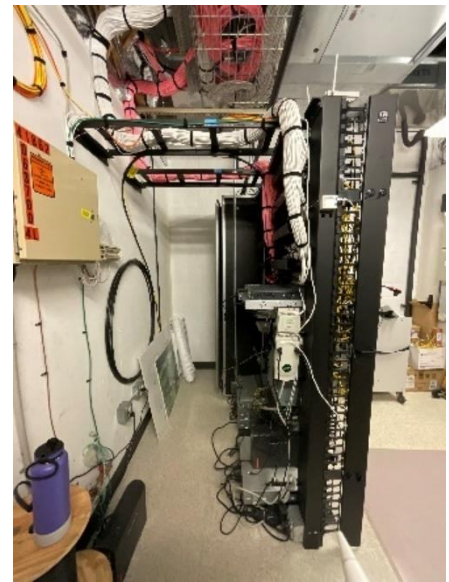
Telecommunications System Improvements

- Cabling is Category 5E which is still loosely supported but is becoming obsolete.

Quantification: Include professional services to develop implementation plan for conversion to CAT6A cabling.

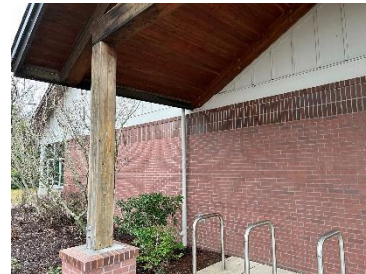
Exterior Brick

- Brick needs to be resealed every 8 years going forward
- Brick control joints need to be replaced every 12 years

- Power wash brick and reseal.
- Remove silicone control joints and replace

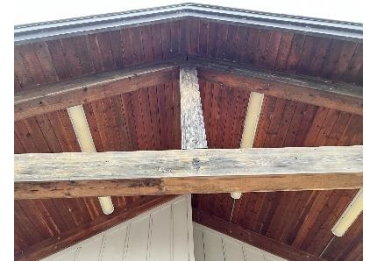
Exterior Wood with Clear Finish

- Finish has aged, cracked and peeled. Wood is stained and has grayed.
- Wood with clear finish should be recoated every three years and sanded and refinished every 12 years as needed

- Sand down wood to remove finish and as much of the staining as possible.
- Apply a wood stain remover product
- Apply three coats of clear spar urethane varnish – satin finish

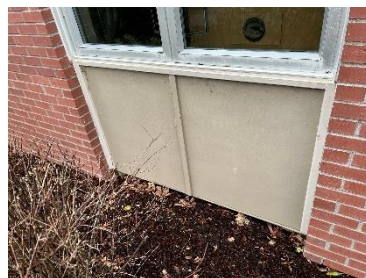
Perimeter Soil Buildup

- Soil has built up over time at the perimeter of the building, blocking brick weeps and causing potential rot / decay at siding systems.

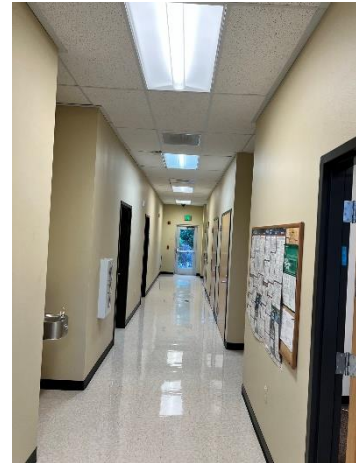
Corner Guards

- Interior outside corners at numerous locations are damaged.

- Repair corners and paint if exposed
- Provide 2"x2" x4'-0" Stainless Steel adhered corner guards
-

Quantification: Provide where needed – approximately 10 locations

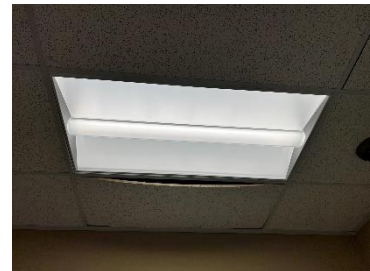
- Ceiling tiles have come loose and are sagging in several locations.

- Ceiling tiles likely become dislodged during wind events that cause a low pressure in the vented attic space. The attic is supposed to be sealed at the bottom chord of the trusses with a plastic scrim material – seal all holes with tape that is rated for exposure in a plenum (Flame spread of 25 or lower and smoke development of 450 max). Additionally, ceiling tile hold down clips can be installed to hold the tiles in place. In some locations a new tile will need to be installed that is sized properly for the opening

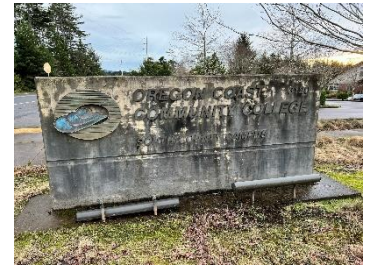
- Monument Sign is discolored and lights are broken.

- Power wash concrete using a low pressure water / bleach / TSP solution to remove any algae growth. Repair any spalling concrete with a concrete patch compound. Remove raised lettering and artwork. Prime concrete and paint with an elastomeric paint system intended for concrete substrates. Reinstall lettering. Replace lighting (included in site lighting package below).

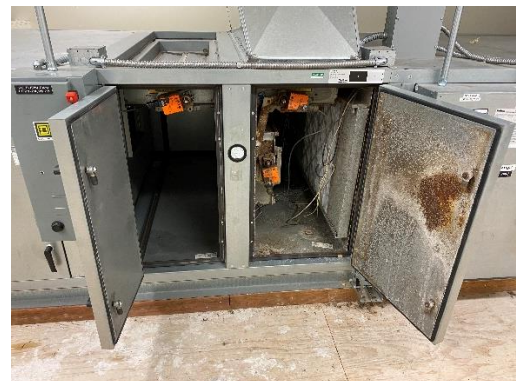
HVAC – Air Handling Unit Component Replacement

- AHU-1 has severely rusted filter section.
- Actuators rusted.

- Replace filter section of AHU and associated control components.
- Recommend installing mist elimination screen into outside air intake to help prevent corrosion.

Quantification: AHU-1 filter section and added screen to outside air intake duct.

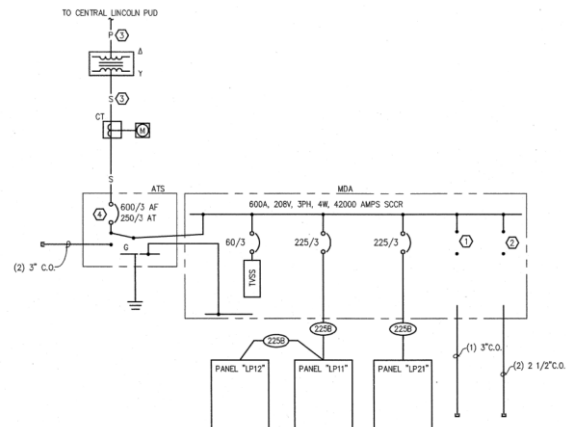
- Periodic testing of electrical system components is recommended to monitor regular deterioration of equipment, devices, connections, and conductors over the system's useful life. Monitoring the electrical system helps to predict and determine scheduled replacements of system components, minimizing operational downtime and improving worker safety.

- Develop preventative maintenance schedule per ANSI/NETA recommendations.
- Visually inspect equipment condition, connections, anchorage, and alignment.
- Perform electrical and mechanical test and inspect operation, connections, conductor insulation, and tap settings.
- Clean and lubricate equipment.
- Include inspections, testing, and servicing of rooftop solar photovoltaic array and associated components.

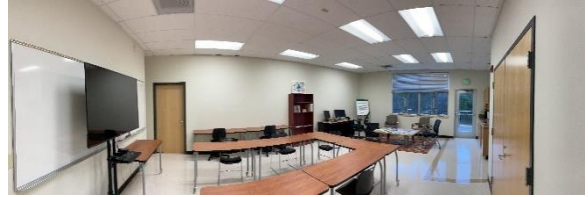
- As remote learning becomes more prevalent, audio-visual systems within these spaces will need to be updated to support the application.

- Develop updated AV standards for classrooms and conference spaces.
- Provide new projectors and supplemental video displays in classrooms to provide adequate visual coverage of the space.
- Provide integrated video and microphone systems to allow for improved remote and hybrid learning environments.
