Request for Qualifications (RFQ)

Project Management Services

For Construction of a New Trades Education Building in Newport, Oregon, and the Improvement, Modernization and Maintenance of Existing College Facilities

OWNER'S REPRESENTATIVE
FOR CONSTRUCTION OF A NEW TRADES EDUCATION FACILITY

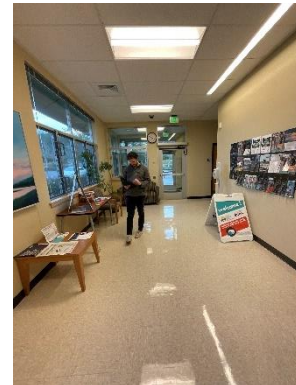
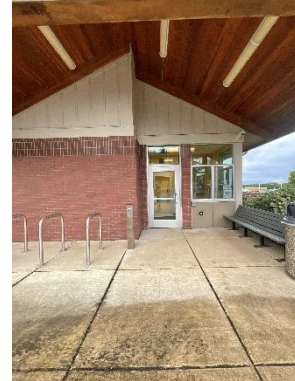
- Interior lighting is fluorescent.
- Building mounted exterior lighting is Metal Halide.
- Parking area lighting is High Pressure Sodium.
- Parking area lighting provides insufficient coverage.
- These older technologies are costly to maintain, requiring regular lamp and/or ballast replacement.
- Controllability for these fixtures is also limited, minimizing energy savings potential through lighting controls.

- Replace and/or retrofit interior lighting with dimmable LED fixtures/lamps.
- Replace and/or retrofit exterior lighting with LED fixtures/lamps.
- Increase number of parking area pole lights to provide full coverage illumination.
- Consider luminaires with Luminaire Level Lighting Controls (LLLC). See Lighting Controls section for more information.

Quantification: Full interior and exterior replacement of existing lighting. Add approximately (3) pole lights with

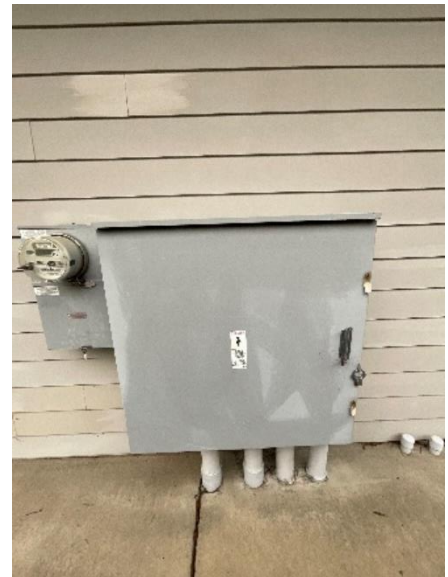
- Meter base and CT enclosures mounted on the building exterior are not marine grade and are showing signs of deterioration.

- Replace exterior equipment enclosures with marine grade stainless steel NEMA 3R enclosures.

Quantification: Utility coordination, temporary disconnection and reconnection of electrical service, new marine grade stainless steel meter base and CT can.

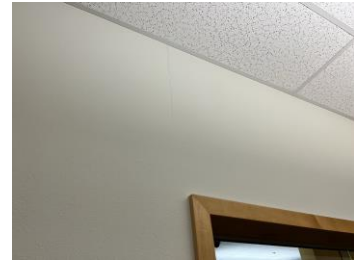
Cracks in Gypsum Board at Foyer

- Cracks have appeared in the gypsum board at the foyer in numerous locations, primarily at the interior relite to room 110, at the openings into Reception 103 and at the beam saddle in the north wall of Upper Lobby 201 near gridline 6. Recurring cracks in these types of locations are typically caused by differential settlement.
- Cracks have also occurred in the hallway at both floors. Control joints should have been installed in continuous gypsum board runs that exceed 30'. Joints should be added in the hallways where the cracks have occurred.
- Recurring cracks in these types of locations are typically caused by differential settlement. But can also be caused by shrinkage due to drying wood framing.
- Differential settlement of up to ½" is indicated in the Geotechnical Report from URS dated January 16, 2006 which is enough to cause cracking.

- Add vertical "V" shaped control joints in the gypsum board that extend down to the substrate at all locations where cracking has occurred. Joint should be USG Control Joint 093 or similar.
- Gypsum board will need to be refinished and repainted.
- In some cases, an additional stud may need to be installed to support the joint.

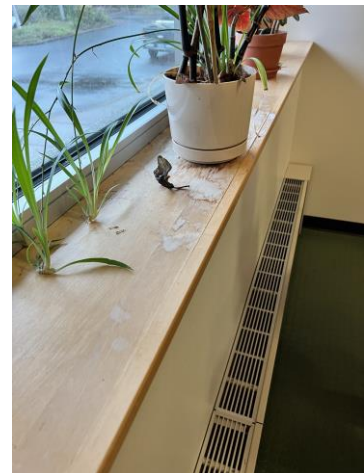
Water Damage at Sills

- There is water damage at a few of the wood window sills. Most can be attributed to plants and watering. Damaged sills due to window leaks are dealt with in other areas.

- Replace the sills with solid surface material if plants are to remain.

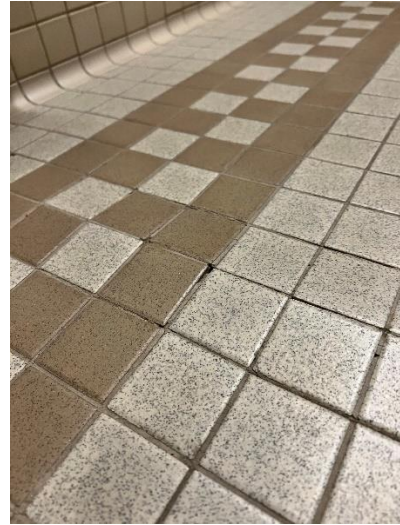
- Substrate has heaved at shower rooms

- Remove loose tile and adjacent adhered tiles
- Grind substrate smooth
- Reinstall tile system to match existing

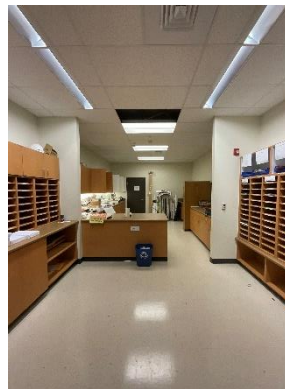
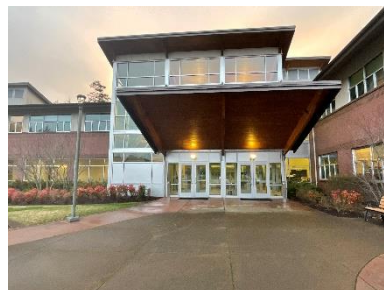
- Interior lighting is fluorescent.
- Building mounted exterior lighting is Metal Halide
- Pole lights are High Pressure Sodium
- These older technologies are costly to maintain, requiring regular lamp and/or ballast replacement.
- Controllability for these fixtures is also limited, minimizing energy savings potential through lighting controls.

- Replace and/or retrofit interior lighting with dimmable LED fixtures/lamps.
- Replace and/or retrofit exterior lighting with LED fixtures/lamps.
- Consider luminaires with Luminaire Level Lighting Controls (LLLC). See Lighting Controls section for more information.

Quantification: Full interior and exterior replacement.

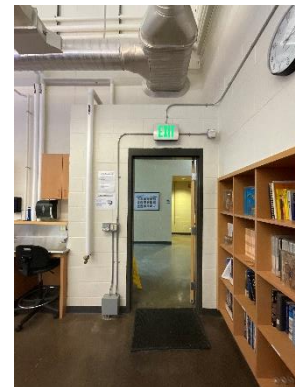
- General area lighting in the Teaching Lab does not operate in a manner that is conducive to the welfare of marine animals housed in the space.
- A complete row of lights is on an emergency circuit. When normal power is lost to the facility, this row of luminaires will automatically come to full brightness, which may cause issues for marine animal welfare in the space.
- Additional lighting appears to be controlled via an astronomical timeclock located in Animal Holding. This system was not indicated on record drawings and requires further study. If it provides timeclock control of luminaires on the egress path, revisions will be required to the lighting control system to ensure egress lights are brought to full brightness upon loss of power.

- Recommission or replace lighting controls in the Teaching Lab. Lighting to be configured for manual-on, automatic-off operation. Initial light level to be at a low setting upon manual-on activation and raised by user input.

- Recircuit row of emergency luminaires to the normal lighting circuit in the space. Provide sealed and gasketed emergency lighting units to provide target illumination on the egress path.
- Review complete control of lighting serving the egress path. Ensure the system utilizes the central Wattstopper control module rather than distributed points of automatic control.

Quantification: Lighting controls and circuiting revisions in Teaching Lab. Upgrade central Wattstopper controller and revise controls for luminaires served by standalone timeclock to be centrally controlled with other luminaires.
